FIRELINE RECLAMATION

TWO FIRE SITES

INTERIOR ALASKA

by Larry Knapman

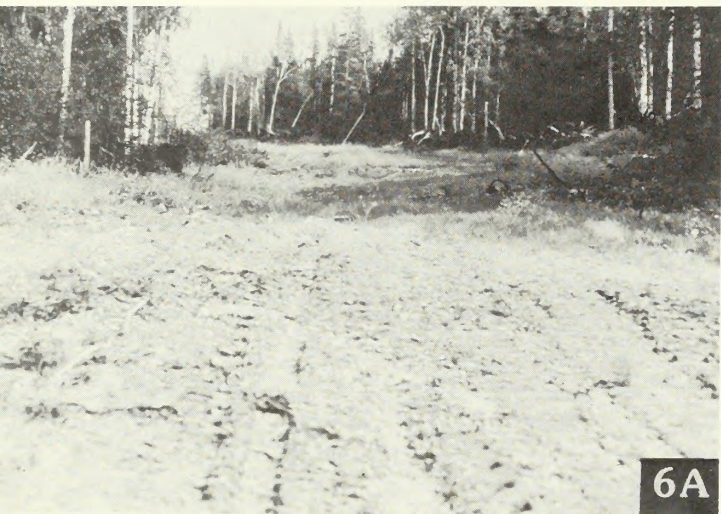
FIGURES 6A, 6B, and 6C show a fireline section on a west-facing slope. The site is well drained and has a spruce, birch, aspen cover type. Photos were taken from the same point 1, 4, and 7 years after the Wickersham Dome fire.

FIGURE 6A--August 1972. Grass has grown in wet areas, with a higher percentage of forbs in the dryer areas. There is little evidence of standing or running water, and only slight erosion has occurred.

FIGURE 6B--September 1975. Ground cover is 90 to 95 percent and blue-joint is the dominant species. Seeded species are rare. No significant erosion has occurred.

FIGURE 6C--September 1978. The fire-line cover has become a shrub type, with willows, alder, rose, and raspberry the most obvious species. Paper birch, aspen, and white spruce also may be seen.

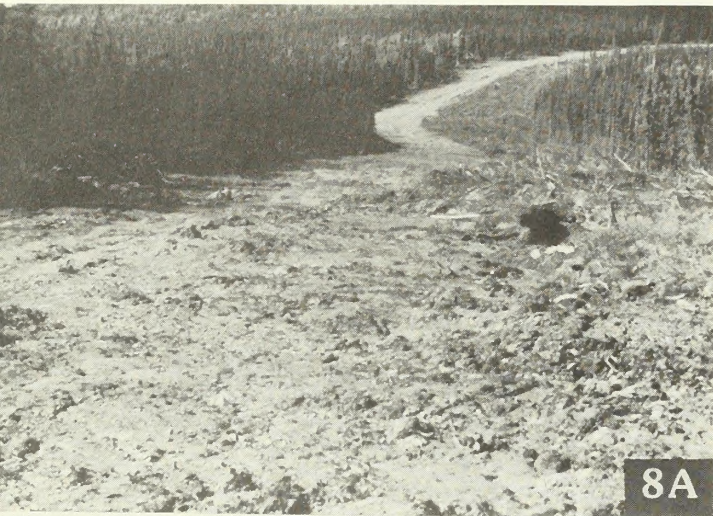
FIGURES 8A, 8B, and 8C show a fireline section on a well-drained, north-facing site in a black spruce cover type. Photos were taken from the same point 1, 4, and 7 years after the Wickersham Dome fire.

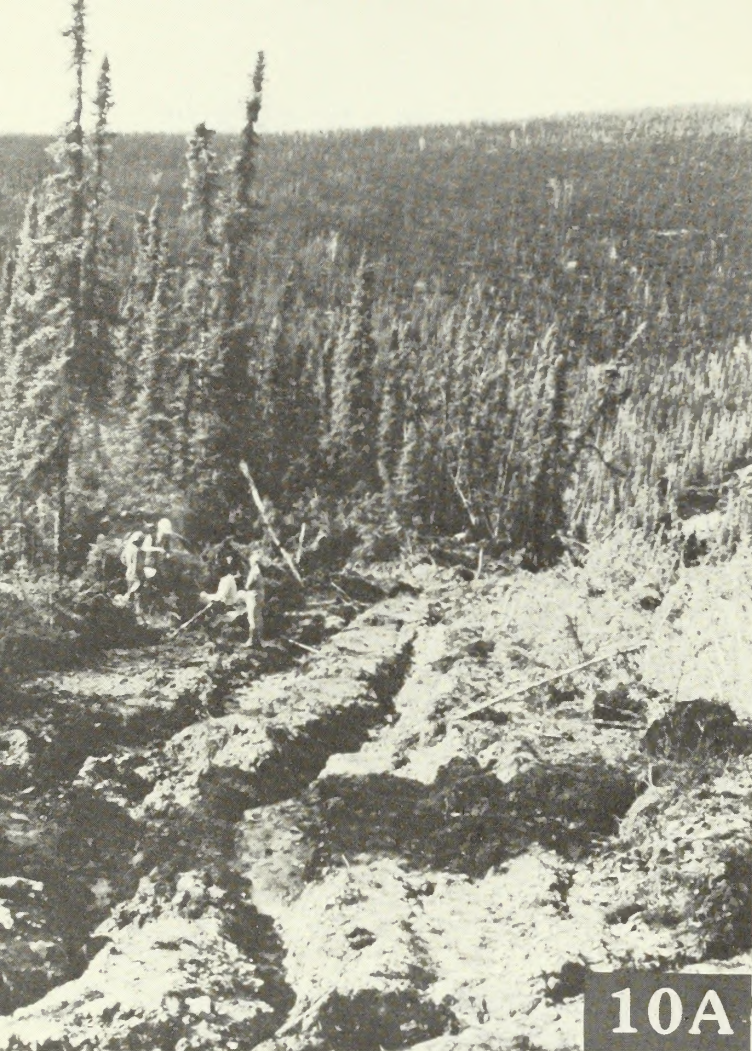
FIGURE 10A--July 1975. The fireline before reclamation began.

FIGURE 10B--July 1975. A section just after the fire crews had replaced the organic material that had been removed during fireline construction.

FIGURE 10C--May 1976, just as spring growth was starting.

FIGURE 10D--September 1977. Grass and horsetail are the most noticeable plant species.

FIGURE 10E--September 1978. Three years after the site was disturbed, revegetation is progressing satisfactorily.

FIGURES 10A, 10B, 10C, 10D, and 10E. The fireline section shown in this series of photos on the Alps fire site is on ice-rich, finely shattered schist materials. It is on a southwest-facing slope, with a black spruce cover type. When the organic mat was removed, the ground ice thawed rapidly, causing solifluction (or slumping of soils) in several steep places. A rainstorm struck 2 days after the fire started. Precipitation from the storm cut gullies up to 20 inches (51 cm) deep. Several water-bars were constructed shortly after the storm was over. Two days later, when reclamation efforts began, the materials were too soft and

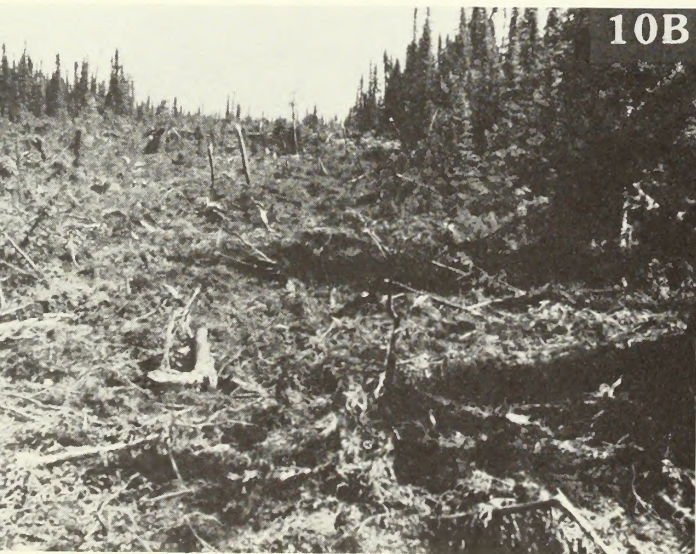
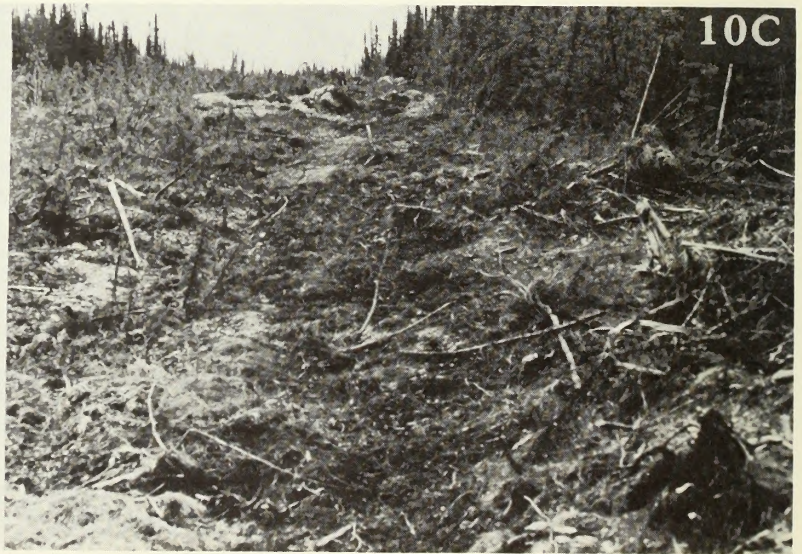
After the fireline was treated, all revegetation was natural, and erosion was practically nonexistent. Although solifluction stopped shortly after the organic mat was replaced, it is questionable that replacing the mat stopped the solifluction.
